# FATIGUE DAMAGE OF 2024-T351 ALUMINIUM ALLOY FRICTION STIR WELDING JOINTS. PART 2: FATIGUE DAMAGE

Aidy Ali<sup>1\*</sup>, Mike W. Brown<sup>2</sup> and Omar Suliman Zaroog<sup>1</sup>

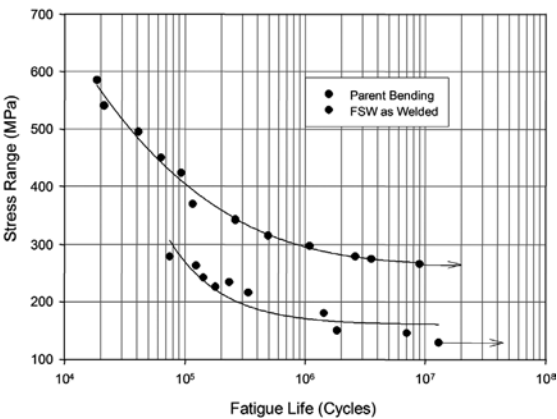
Figure 3 represents the stress vs. number of cycle to failure (S-N) data for the parent material and FSW as-welded specimens. Obviously there is a tremendous drop in the fatigue strength of FSW as-welded compared with the parent plate. Since surface irregularities can degrade the fatigue strength, Figure 4 shows the S-N data for FSW as-welded and FSW

Figure 3. Stress life curves for FSW as welded versus parent plate of 2024-351 AL Alloy with load ratio R = 0.1

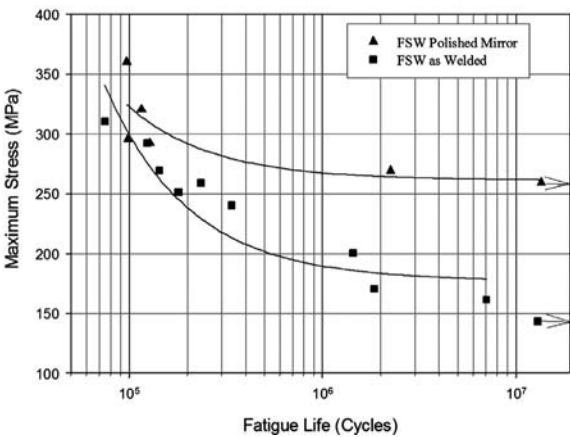
Figure 4. Stress life curves for FSW as welded versus FSW polished mirror of 2024-T351 AL Alloy with load ratio R = 0.1

mirror-polished specimen. It is worth noting that there is a significant life improvement was found, specifically in the high cycle fatigue (HCF) regime when the surface irregularities were removed by the mechanical polishing. Fatigue is hailed as a defect sensitive property. As a rule of thumb, any parameter that will increase the local stress concentration will also degrade fatigue performance. How surface irregularities can degrade fatigue strength, especially in the HCF regime is investigated using SEM and EDX analysis. In order to investigate the initiation origin and its causes, two fracture surfaces were taken from the HCF and low cycle fatigue (LCF) regimes in both FSW as-welded and FSW polished mirror and were examined.

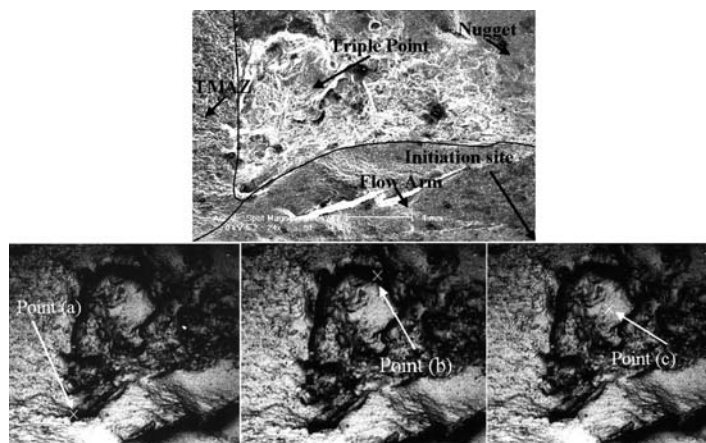
**Figure 5.** SEM fractograph and EDX analysis position of initiation images for LCF of 2024-T351 AL Alloy FSW as welded specimen at 292 MPa applied stress with load ratio  $R = 0.1$

Further investigation was carried out to take advantage of the higher resolution in SEM and, working together with the EDX analysis, revealed the initiation site in FSW. Figure 5 illustrates the initiation site in the LCF FSW as-welded. It is evident that the crack was initiated from the free surface, propagating to the triple point regime, and causing a severely fractured surface. We used the EDX analysis to investigate any inclusion in the triple point location at several positions which were labelled as Point (a), Point (b) and Point (c) as shown in Figure 5. Table 1 represents the chemical composition of the material at each position of interest from the EDX analysis. Point (b) exhibits an enormous amount of oxygen (54.43%) which is believed to cause formation of the severely fractured surface that accelerates the crack growth and which is located approximately 3 mm from the top free surface of the weld. Nevertheless, both position Point (a) and (c) exhibit small amount of oxygen confirmed by the mechanism in the triple point regime where the grain is severely elongated due to stirring in the FSW process.

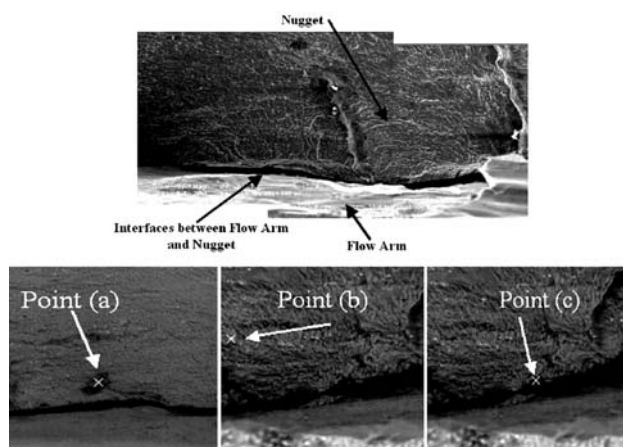
between the Flow Arm and Nugget regime with approximately 50 - 100  $\mu$ m depths as shown in Figure 6. EDX analysis which was performed at three positions of interest shown in Figure 6. The figure revealed that, one of the cracks started from broken or debonded precipitate at Point (c) and oxygen was also found in this transition zone as shown in Figure 7. It is worth noting that one of the initiations was mainly started at a silicon oxide inclusion at Point (a) which contains 66.42% of silicon and 11.25% oxygen as summarised in Table 2; that caused the subsurface crack initiation to occur. Further EDX analysis passing the transition zone at Point (b) revealed there is no clear indication of an inclusion and a high amount of trapped oxygen.

**Figure 6.** SEM fractograph and EDX analysis position of initiation images for LCF of 2024-T351 AL Alloy FSW polished mirror specimen at 300 MPa applied stress with load ratio  $R = 0.1$

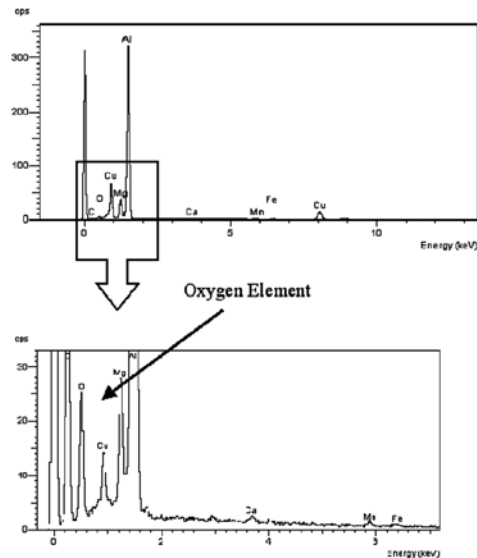
**Figure 7.** EDX analysis showed that the chemical composition of the material at position point (c) LCF of 2024-T351 AL Alloy FSW polished mirror specimen at 300 MPa applied stress with load ratio  $R = 0.1$

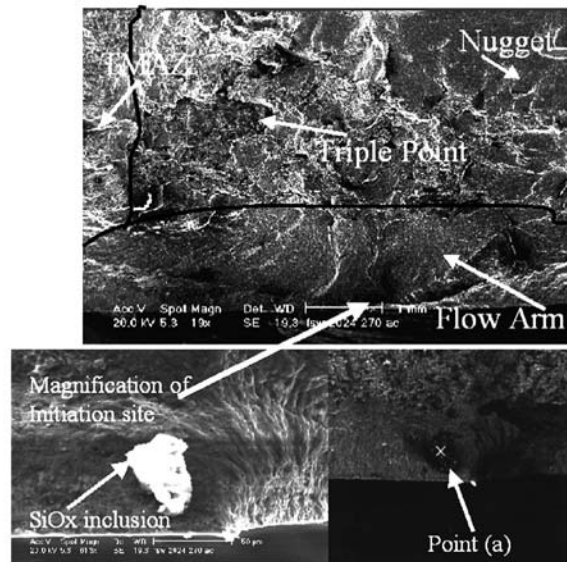
For the HCF of the polished sample, when the crack surface was observed at high magnification, the crack initiation point was shown to have initiated inside the Flow arm causing severe damage experienced by the material at the triple point regime as illustrated in Figure 8. In order to reinforce the idea that the inclusion was part of the material prior to failure, EDX spots at Point (a) in Figure 8 were selected at the perimeter of the inclusion. As a result, a white feature in Figure 8 was analysed and found to contain an inclusion with 67.07% silicon and 12.13% oxygen in the composition as summarised in Table 3. Further high magnification near

**Figure 8. SEM fractograph and EDX analysis position of initiation images for HCF of 2024-T351 AL Alloy FSW polished mirror specimen at 270 MPa applied stress with load ratio  $R = 0.1$**

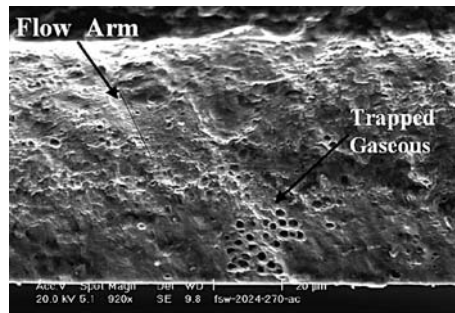
the surface, by SEM analysis, confirmed the existence of trapped gaseous elements within the Flow Arm as shown in Figure 9.

**Figure 9.** SEM fractograph confirm the existence of trapped gaseous elements at near surface depth within the flow arm for HCF of 2024-T351 AL Alloy FSW polished mirror specimen at 270 MPa applied stress with load ratio  $R = 0.1$

5. The Severely fractured surface in the triple point regime is due to trapped gaseous elements found located at 3mm depth from the surface.

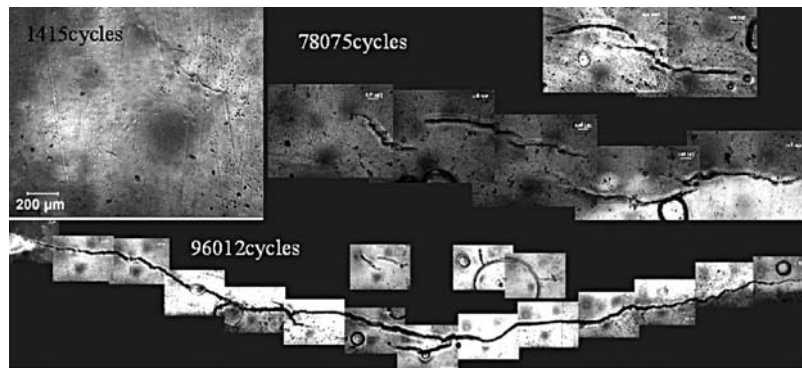
Having analysed the SEM and EDX results, the fatigue initiation of FSW 2024-T351 AL Alloy was influenced by material defects such as inclusion and porosity. Replica images for the mirror-polished LCF specimens in Figure 10 confirm the occurrence of multiple crack initiation, causing crack coalescence and overlapping. On the other hand, the replicas images captured from the HCF of the polished samples shown in Figure 11 confirm a single crack initiation and propagation until final fracture.

**Figure 10.** Replica images for LCF of 2024-T351 AL Alloy FSW polished mirror specimen at 300 MPa applied stress with load ratio  $R = 0.1$

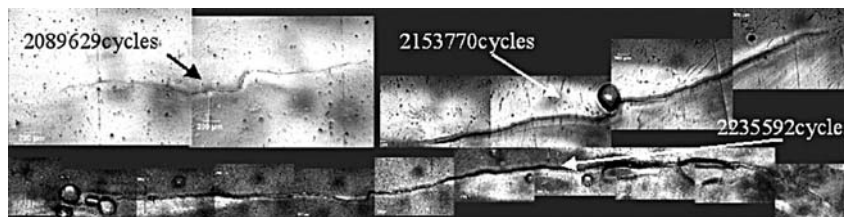
**Figure 11.** Replica images for HCF of 2024-T351 AL Alloy FSW polished mirror specimen at 270 MPa applied stress with load ratio  $R = 0.1$
