# STRUCTURAL HEALTH ASSESSMENT OF RCC MEMBERS USING NON-DESTRUCTIVE AND PARTIAL DESTRUCTIVE TECHNIQUES AT ELEVATED FLOOR LEVEL OF A SPORTS STADIUM

This study presents a comprehensive evaluation of reinforced cement concrete (RCC) members situated at the +10.80 m level of an international cricket stadium in Gwalior, Madhya Pradesh, utilizing a series of nondestructive Tests (NDT) and Partial Destructive Tests (PDT). The investigation was undertaken to assess the in-situ material quality and structural integrity of slabs and beams using Ultrasonic Pulse Velocity (UPV), Rebound Hammer, and Core Compression and Chemical Analysis. The UPV results indicated a significant portion of the slab concrete quality falls within the “doubtful” category, while beams ranged from “medium” to “good” quality. Rebound hammer readings generally revealed surface hardness which, when correlated to compressive strength, suggested values potentially lower than the design grade (M30). Core compression tests revealed non-uniform in situ compressive strength (20.78–41.34 MPa); although most cores satisfied the M30 design grade, chloride concentrations exceeding IS 456:2000 limits establish a durability-govern

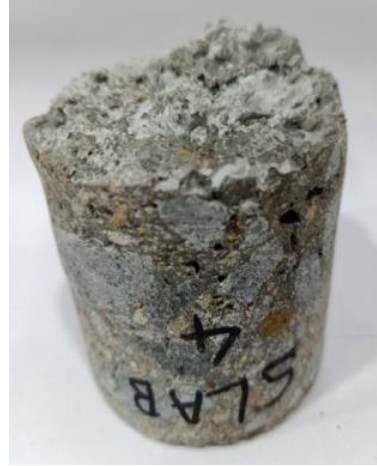
Core compression tests were conducted to determine the in situ compressive strength of the concrete in accordance with IS 516:1959 (BIS, 1959). Six cylindrical core samples were extracted from the RCC members at the +10.80 m level, comprising five samples from the slab and one from the beam. Each core had a diameter of 67 mm and was drilled vertically using a rotary diamond coring machine. The locations were selected with the aid of a Ground Penetrating Radar (GPR) to ensure the

avoidance of reinforcement bars and capture structurally representative concrete zones (Figure 4). After extraction, the cores were carefully cleaned and their end surfaces were ground flat and perpendicular to the core axis. To ensure uniform stress distribution during testing, sulfur or gypsum capping was applied to both ends of the cores.

Figure 4. Workflow of core extraction, trimming, capping, and testing for compressive strength as per IS 516:1959

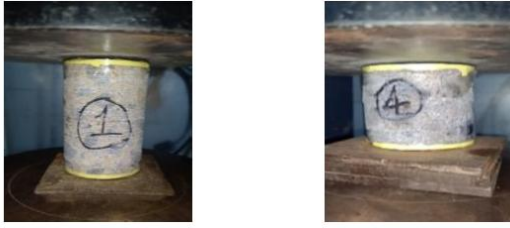
Compressive strength testing was performed using a 2000 kN capacity compression testing machine (CTM), as shown in Figure 5. The load at failure, denoted by  $W$ , was recorded for each sample. When reinforcement marks were observed within the core, a steel correction factor was applied to account for their influence on the failure load. The corrected load  $W_c$  was calculated using the formula shown in equation 3:

**Figure 5. Compressive strength test setup showing cored specimen positioned in the CTM**
